## USE OF A CERAMIC WOUND DRESSING\* COMBINED WITH BACTERIAL FLUORESCENCE IMAGING\*\* – BASED DIAGNOSTIC IN THE TREATMENT OF CHRONIC WOUNDS: A PILOT STUDY

*Robert Strohal, MD, Head, Department Dermatology and Venereology, Federal Academic Teaching Hospital of Feldkirch, Austria  
Gilbert Hämmerle, Central Ambulance of Wound Care, Department of Nursing, Federal County Hospital of Bregenz, Austria*

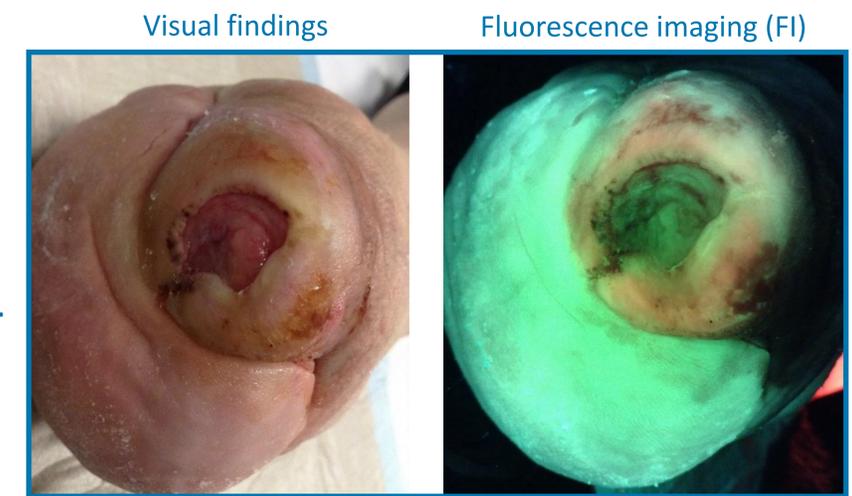
Day 1

**Day 1:** in contrast to the visual assessment, FI analysis revealed an increased bacterial load (red-brown colour) especially in the peri-wound skin; based on the findings obtained by FI, the antimicrobial therapy with a ceramic wound dressing was initiated.

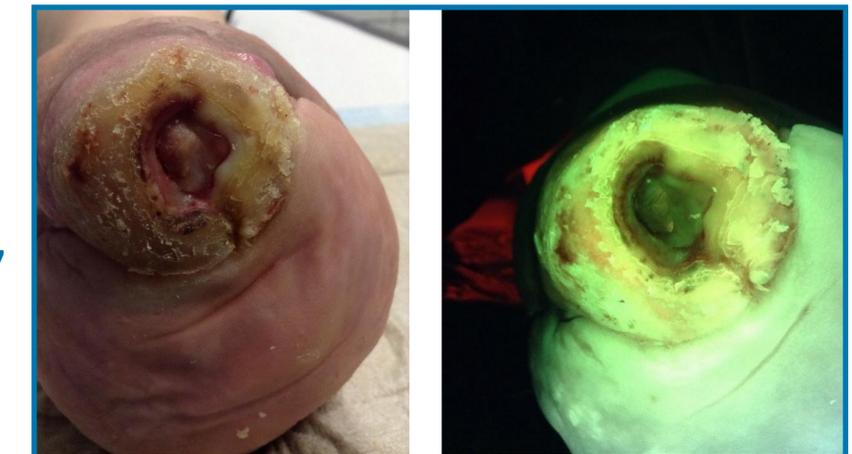
Day 7

**Day 7:** only slight bacterial load remained beneath the hyperkeratosis, recognizable by the red-brown coloration in the FI.

- ➔ FI analysis allowed early diagnosis of the infection and the prompt initiation of an appropriate antimicrobial treatment.
- ➔ The efficacy of the antimicrobial therapy already after 7 treatment days was approved by FI.

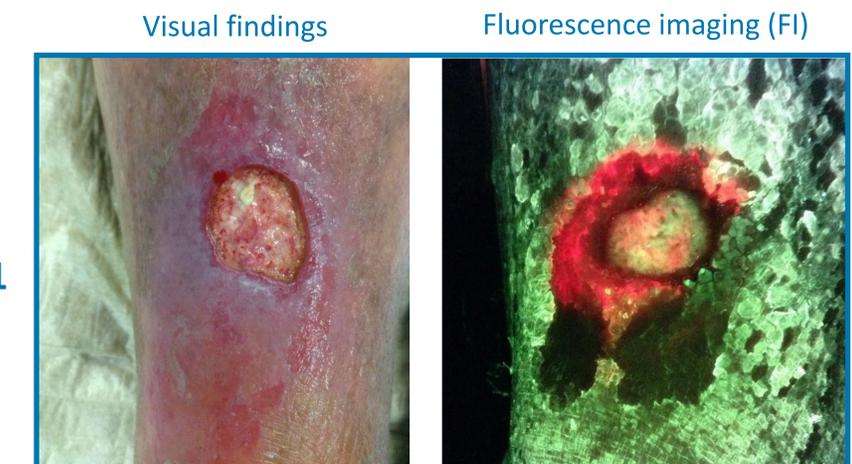
Day 1

**Day 1:** a massively increased bacterial load (red color) especially in the wound surrounding was detected using the FI device; based on this diagnosis of infection, the wound was treated with the antimicrobial ceramic dressing.

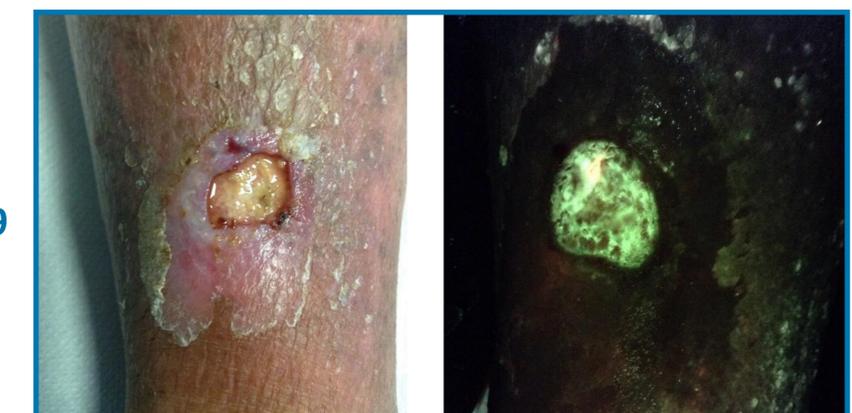
Day 9

**Day 9:** by using FI, no bacteria were detected.

- ➔ Due to FI analysis the infection was detected and an adequate wound therapy could be initiated.
- ➔ The efficacy of the antimicrobial therapy was examined via FI and proved to be effective already at day 3 after start of therapy.

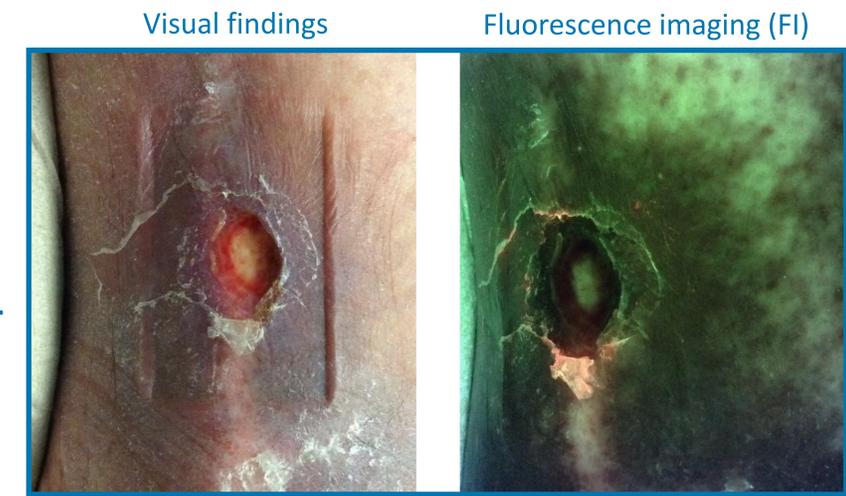
Day 1

**Day 1:** the bioburden mainly at the wound border beneath the skin scales was detected only by FI analysis; based on the evidence that a bacterial infection in the wound was present, an antimicrobial therapy with the ceramic wound dressing was started.

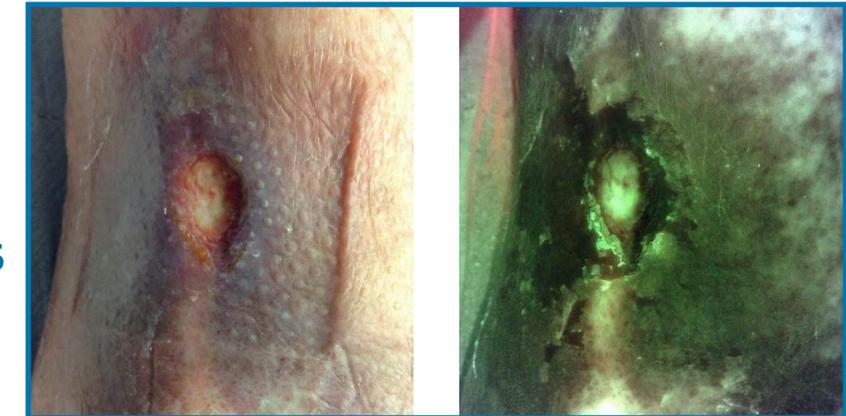
Day 5

**Day 5:** by using FI, it could be demonstrated that the wound tissue was free of bacterial load.

- ➔ By using FI analysis, the early diagnosis of infection and the prompt initiation of an antimicrobial treatment was possible.
- ➔ Therapy with the ceramic dressing was effective and no bacteria were detected in the wound already at day 5 after treatment start as proven by the FI analysis.

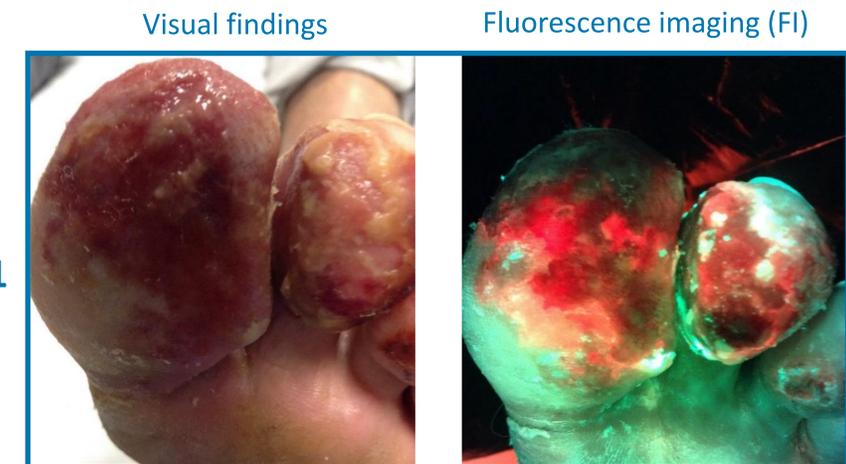
Day 1

**Day 1:** clear clinical signs of fungal infection were optically visible; however, the FI analysis revealed an additional massive bacterial load with Gram-positive as well as Gram-negative bacteria, prompting the initiation of an antimicrobial treatment.

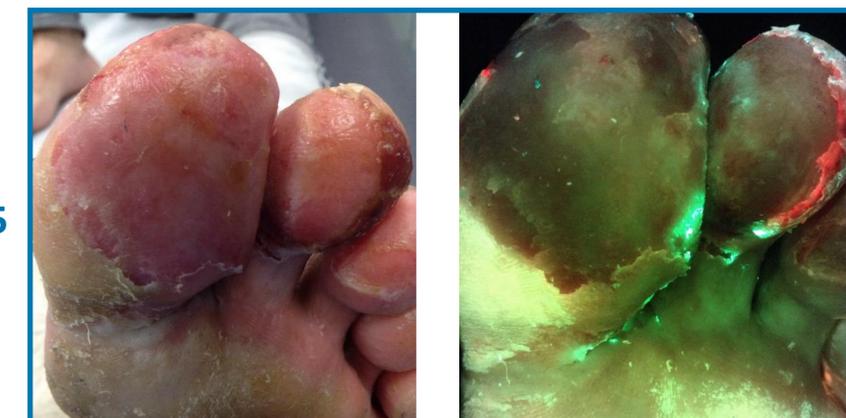
Day 5

**Day 5:** only a minor bacterial load remaining below the skin scales could be detected by using the FI device; the substantial improvement of the wound situation was optically visible.

- ➔ FI analysis revealed that impairment of wound healing was caused by bacterial load rather than by fungal infection.
- ➔ Antimicrobial efficacy of the ceramic dressing was demonstrated already at day 5 after therapy start by FI.

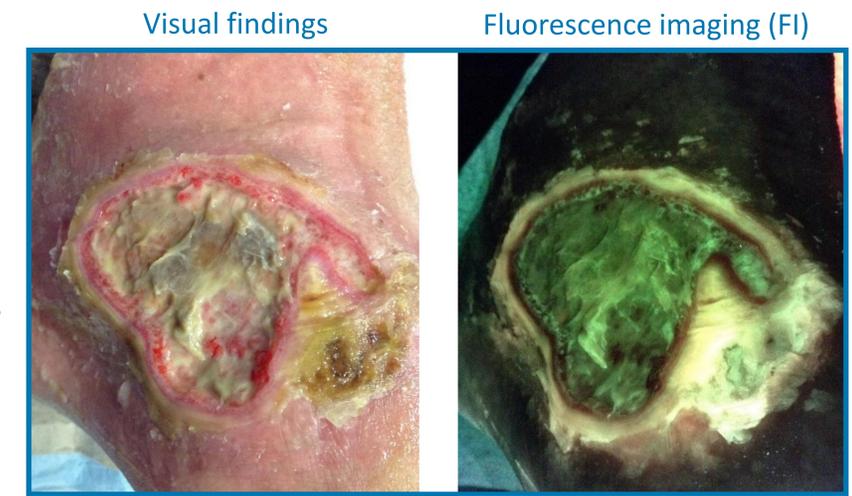
Day 1

**Day 1:** the painful wound was covered with slough, an increased bacterial load (light green colour) mainly in the peri-wound skin was observable with FI; based on these findings the wound was treated with an antimicrobial ceramic dressing.

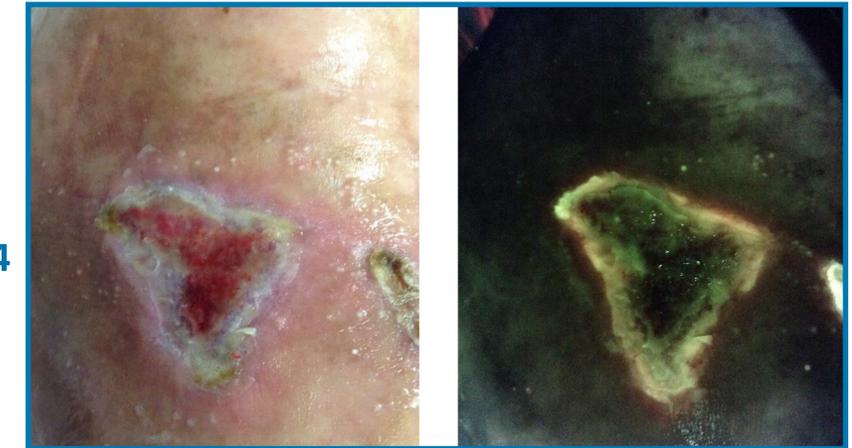
Day 14

**Day 14:** increased epithelialization of the wound was detected and FI analysis proved that no bacteria remained in the wound.

→ Based on the FI analysis, the efficacy of the ceramic wound dressing was determined already after 7 treatment days.

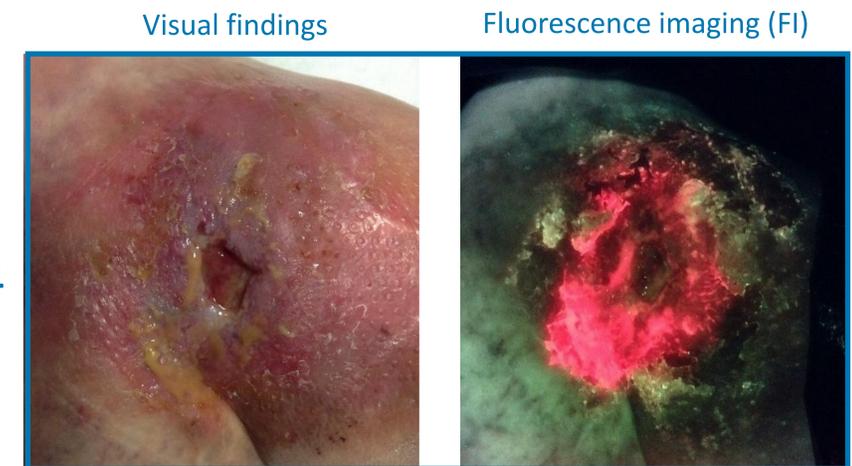
Day 1

**Day 1:** the wound displayed clear optically visible clinical signs of infection, a massive bacterial load mainly in the peri-wound skin was detected by using FI.

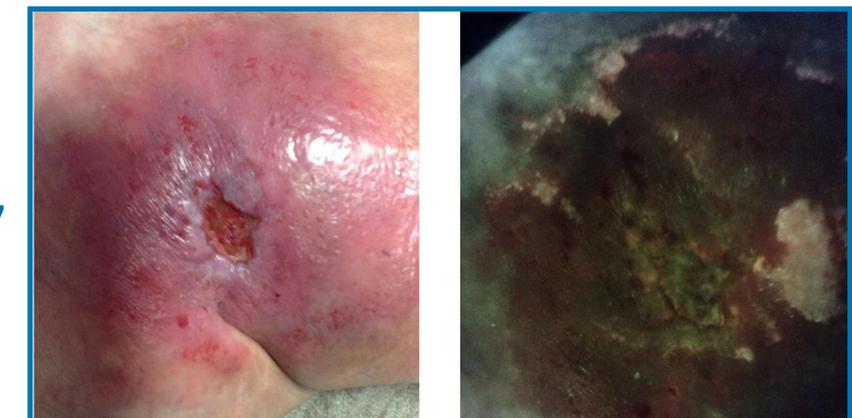
Day 7

**Day 7:** no bacteria were detectable as shown in FI analysis, a marked improvement of the wound condition was optically visible.

→ Therapy with the antimicrobial dressing was effective already at day 3 after treatment start as proven by FI analyses.
